**CONTROL OF LEAKAGE THROUGH JOINTS
IN CAST-STONE MASONRY AT
THE NATIONAL NAVAL MEDICAL CENTER**

**Progress Report No. 1
by
A. Hockman, E. J. McCamley and
E. W. Krussell**

**To
District Public Works Office
Potomac River Naval Command
Bureau of Yards & Docks
Department of the Navy**

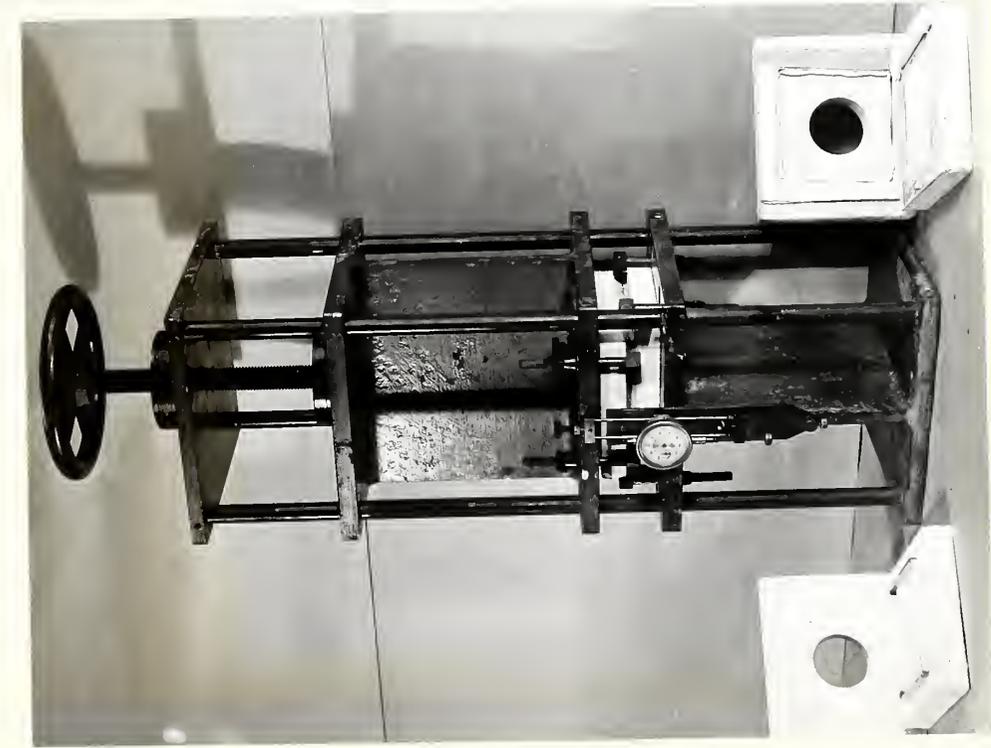
The apparatus used to make this test is described in Federal Specification SS-R-406c, No. 223.11, for testing asphalt joint sealers. Two cast-stone blocks, forming a joint 2 x 2 x 3/8 in. is filled with calking and allowed to cure for 30 days at room temperature. After the test specimen is placed in a cold box for at least 4 hours, it is clamped into place in the stretching machine, and the blocks drawn apart at the rate of 1/8 in. per hour until the joint is extended 1/10 in. (figure 11). During the test the temperature is maintained at 0°F. Observations are made of the bond and plasticity properties.

Fig. 11. Bond and plasticity test at 0° F. Calking in specimen is shown in place between two clamps ready for test.

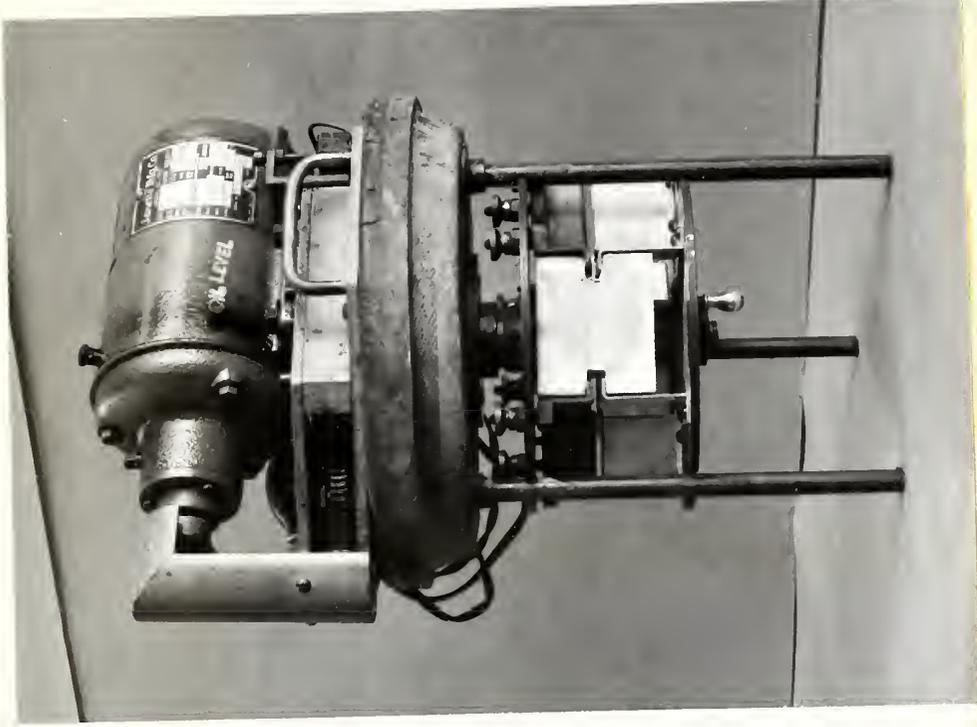
The joint tested is made between two slabs of cast-stone, 6 by 7 by 1 in., one of which has a 2 1/2 in. round hole. Calking is placed between slabs which are held apart by a 1/4 in. brass spacer, making a joint 1/4 in. thick and 3/4 in. deep on all four sides of the stone. (Figure 10). After 30 days of curing at room temperature, the slabs are drawn apart by a special apparatus (figure 10), the amount of separation being measured by a 0.001 in. micrometer dial gage. At the start of the test, water is poured into the hole of the top block and the joint is watched for leakage as the blocks are drawn apart. Figure 10, right, shows a compound after test in which premature failure was caused by lack of bond.

Fig. 10. Bond and plasticity test at room temperature. Left, cast-stone blocks before calking is applied. Center, calking under test. Right, example of failure of calking due to lack of bond.

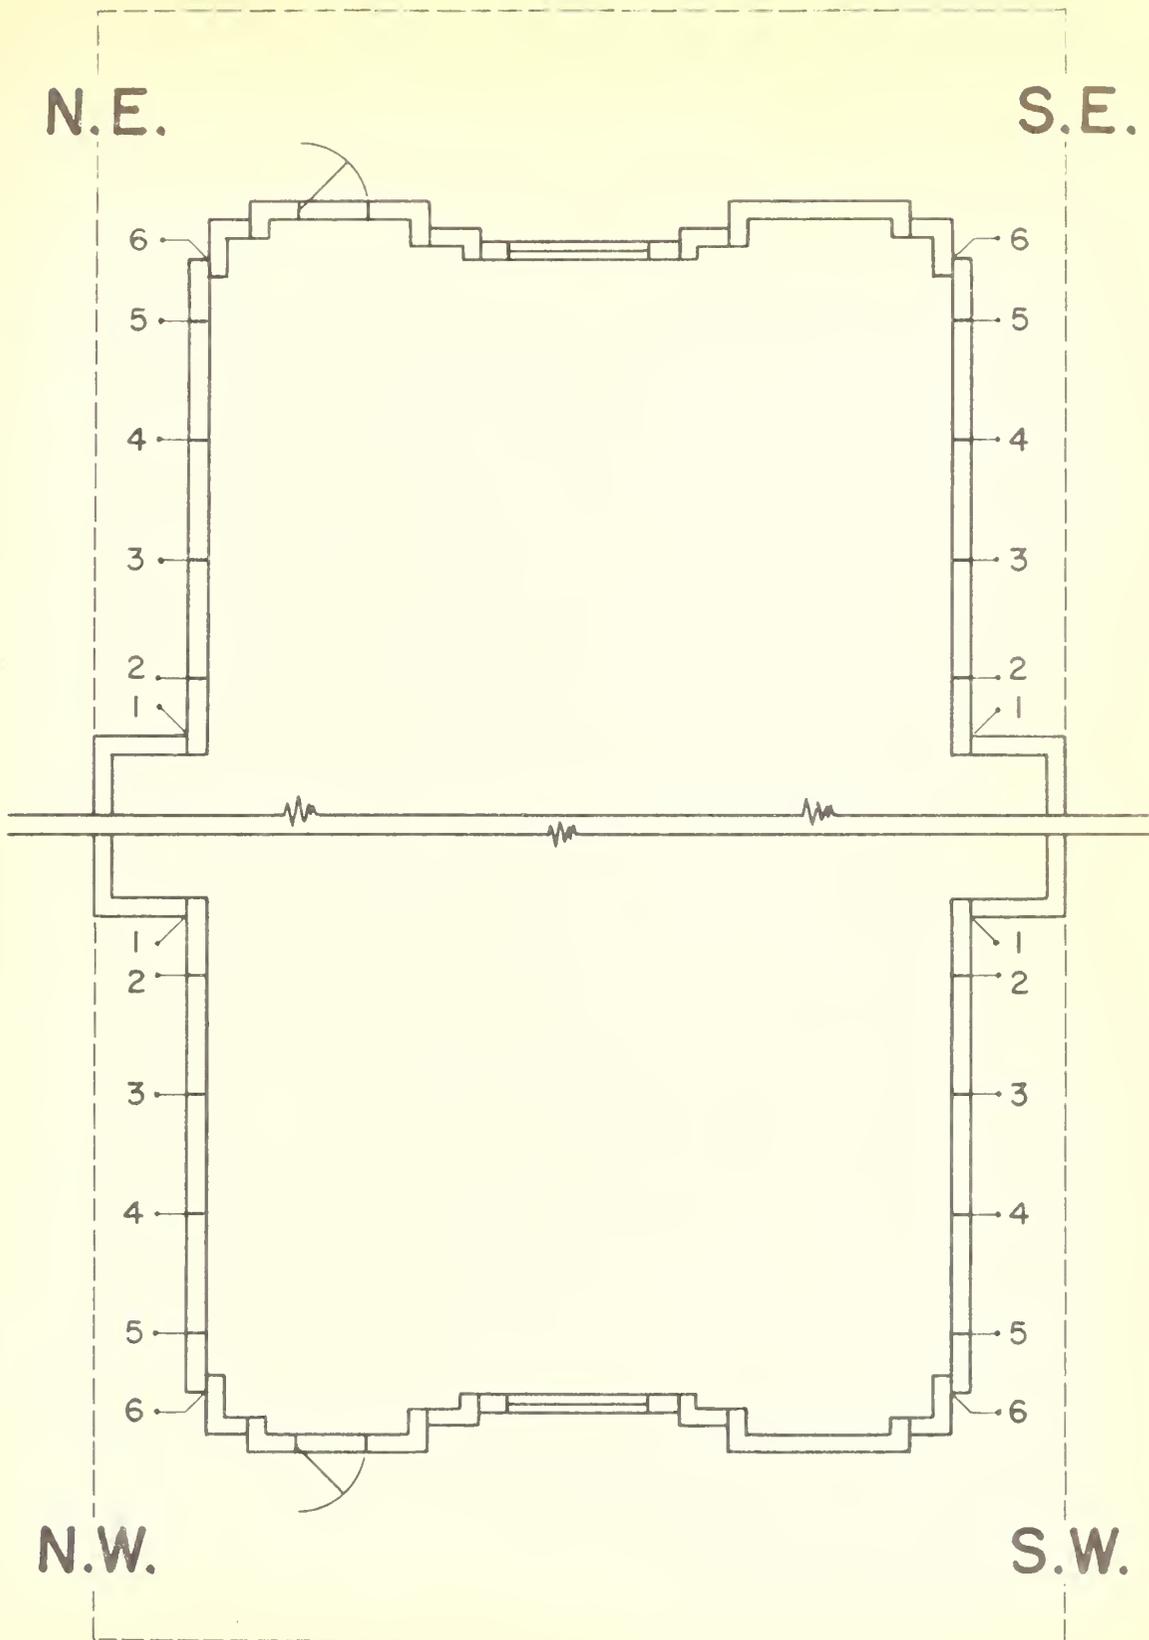
Figures 13 and 14 give the exact locations of the gage stations installed in the cast-stone panels on the northeast, northwest, se and sw elevations. At the start of the investigation, six stations were installed at each elevation in such manner that each station straddled a vertical joint at the 4 1/2 ft. level. Stations Nos. 1 and 6 were installed for measurement of panel movements in corners. After many unsuccessful attempts were made to obtain dependable and accurate measurements of the corner joint movements, it was decided to abandon the corner stations and restrict the measurements to stations 2, 3, 4, and 5, on all four sides of the building.

FIGURE NO. 13 PLAN VIEW SHOWING LOCATION OF ALL GAGE STATIONS USED IN MEASUREMENT OF JOINT MOVEMENTS. (19TH FLOOR LEVEL, BUILDING NO. 1, NAVAL MEDICAL CENTER.)

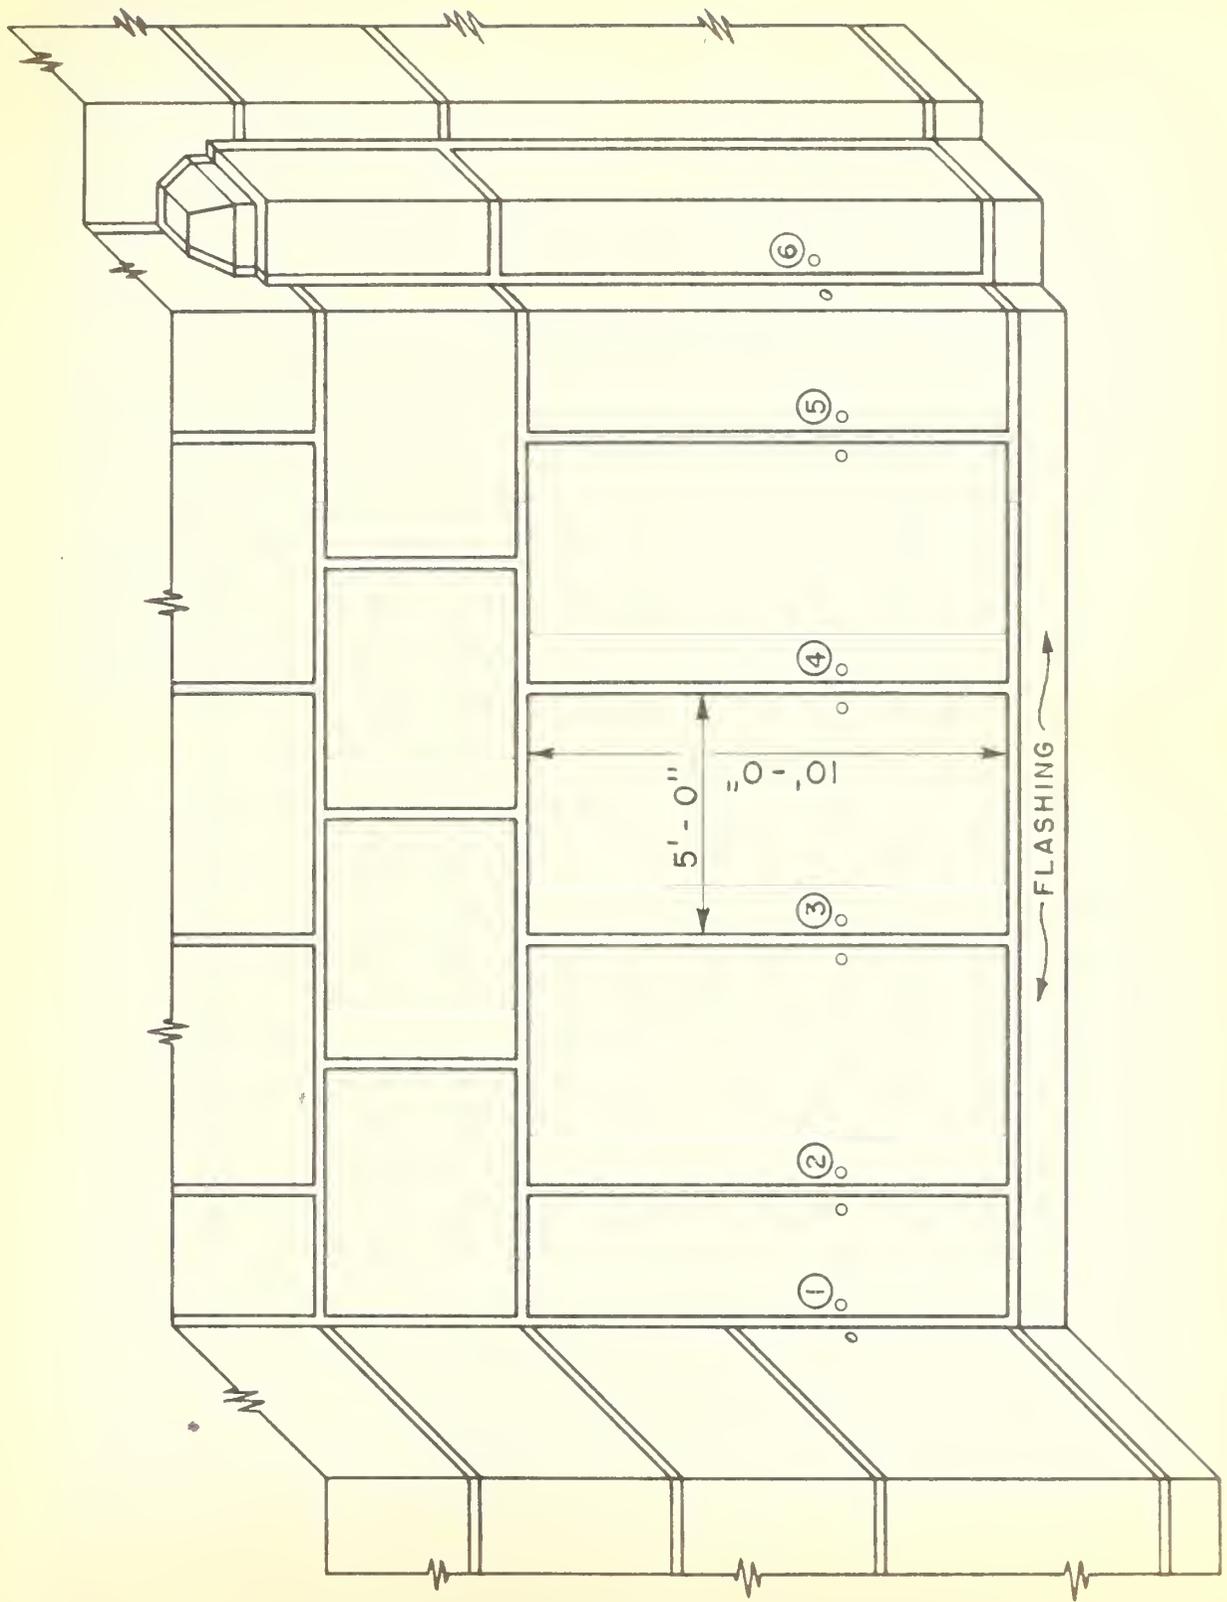
FIGURE NO. 14 TYPICAL WALL ELEVATION SHOWING LOCATION OF ONE SET OF GAGE STATIONS USED IN MEASUREMENT OF JOINT MOVEMENTS. (19TH FLOOR LEVEL, BUILDING NO. 1, NAVAL MEDICAL CENTER.)

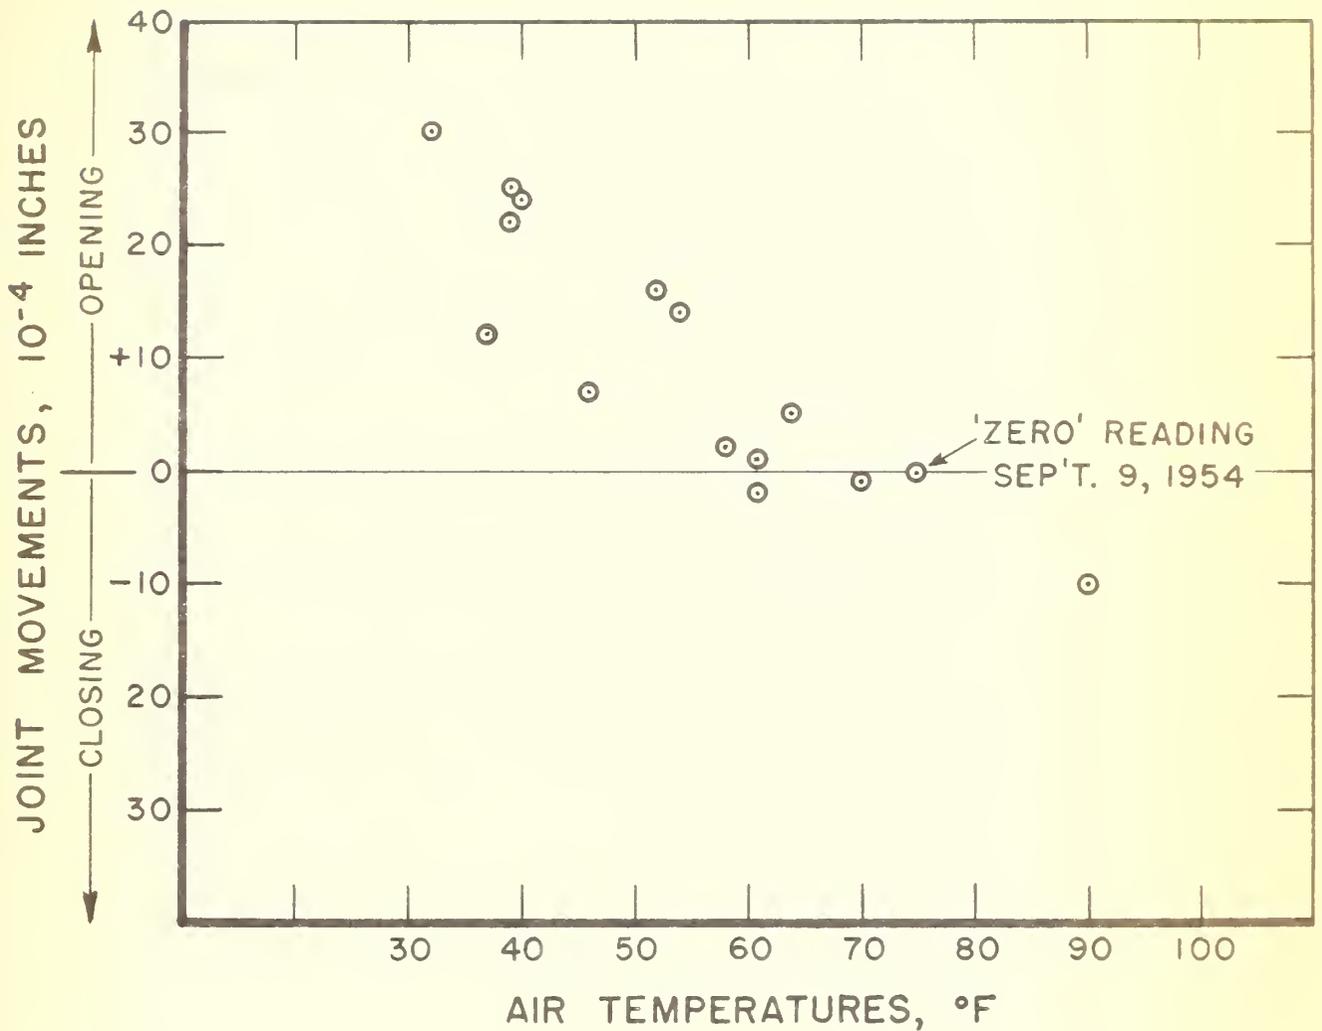
Figure 16 and table 3 give the complete record of joint movements as measured at all 16 gage stations on 15 separate occasions from September 9 to April 27, 1955. In general, the joint movements were directly related to the changes in temperature. A rise in temperature caused the cast-stone panels to expand which resulted in a closing or contraction of the joints. This is illustrated by the September 29 readings, when the temperature rose to 90°F and the joints contracted in most instances (cast-stone panels expanded). Similarly, a drop in temperature to 39°F on December 4, 1954, caused most of the joints to open or expand (cast-stone panels contracted). Figure 17 shows the correlation between the joint movements and the air temperature recorded at the time of gage readings.

FIGURE NO. 17 RELATIONSHIP BETWEEN JOINT MOVEMENTS AND AIR TEMPERATURES RECORDED AT THE TIME GAGE READINGS WERE TAKEN. EACH POINT REPRESENTS THE AVERAGE DATA OBTAINED ON EACH OF THE 15 DAYS THAT MEASUREMENTS WERE MADE FROM SEP'T. '54 THROUGH APRIL '55. (19TH FLOOR LEVEL, BUILDING NO. 1, NAVAL MEDICAL CENTER.)

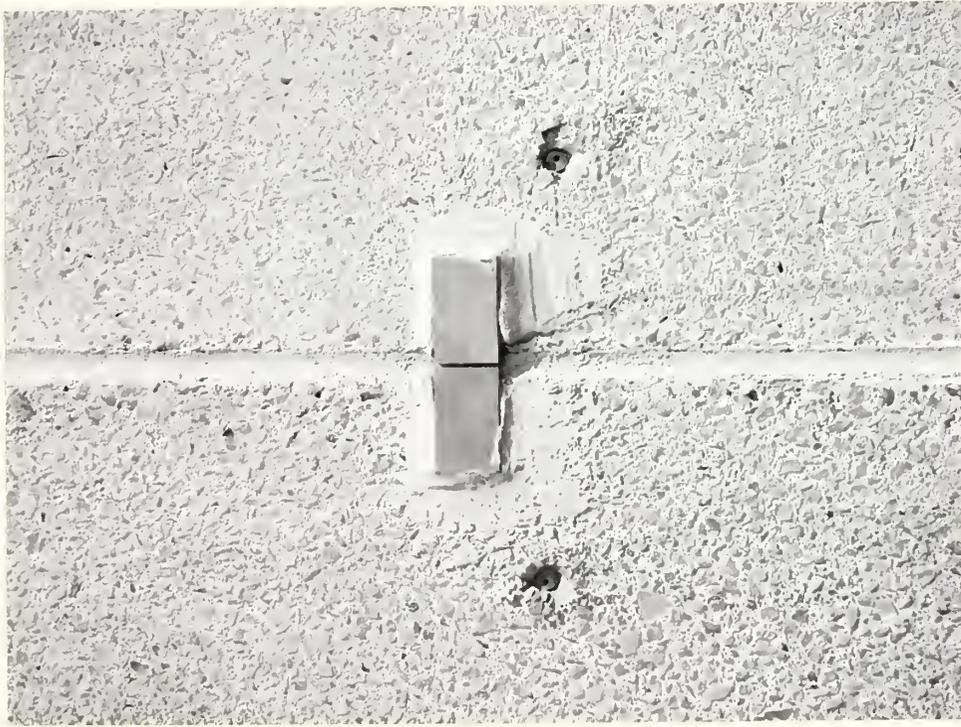
A.

Fig. 19. (A) Type of gage station, (rectangular stainless steel strips), being used at the present time for measurement of joint movements.
(B) Operator measuring the distance between steel strips with a Brinell microscope.

1. The method of measuring the joint movements will be changed with the hope of obtaining more accurate data. The Brinell microscope, reading directly in hundredths of millimeters will replace the Whittemore strain gage. Figure 19 illustrates the microscope and the type of gage station that will be installed for its use. Joint movements will be measured at more frequent intervals and especially after long periods of extreme hot and cold weather.
